# Non-healing lower extremity wounds

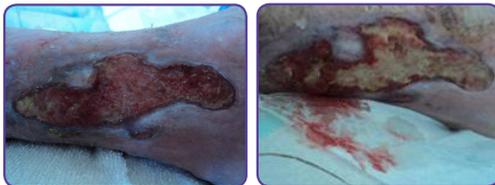
Non-healing leg ulcer (4.5 years)  
prior to PICO therapy

78-year-old female with the autoimmune disease Sjögren's syndrome. A 10cm x 5cm wound on the lower limb failed to respond to conventional wound management therapy that the patient had been receiving up to 3 times a week for 4.5 years. The painful non-healing wound was significantly affecting the patients quality of life and not surprisingly, the patient had given up hope of ever healing her wound.
